Manhole Inspection Summary

Manhole # S51K__042MH

Insp Date: **4/1/08 9:31 AM**

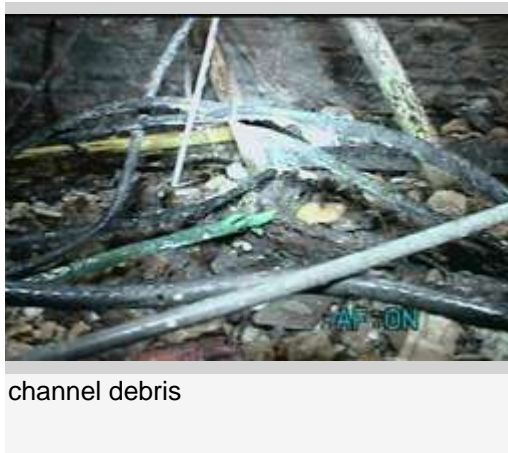
Defect 4

Condition: ☐ Sound ☐ Cracked ☐ Root Intrusion ☐ Deteriorated ☐ Leaks ☒ **Debris**

channel debris

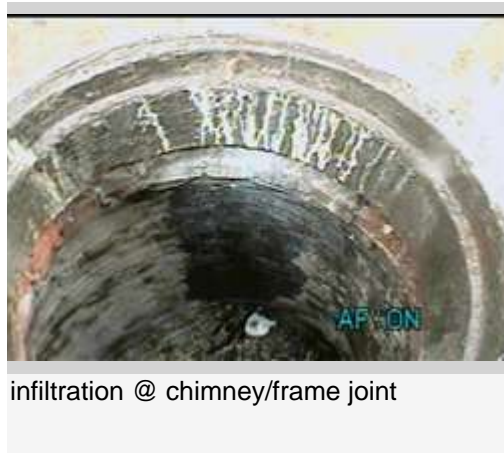
Defect 3

Infiltration: ☐ None ☒ **Joint** ☐ Cracks ☐ Mortar ☐ Roots ☐ Wall

infiltration @ chimney/frame joint

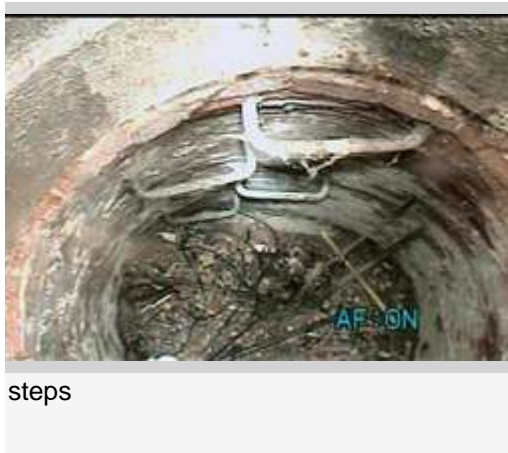
Defect 2

Count: **5** Missing: **0** ☒ **Corroded**

steps

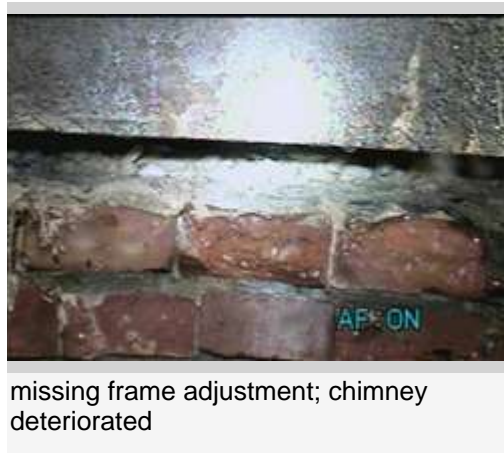
Defect 1

Condition: ☐ Sound ☐ Cracked ☐ Root Intrusion ☐ Loose Brick ☒ **Deteriorated**

missing frame adjustment; chimney deteriorated
